根尖性歯周炎に隣在するインプラントの予後

Apical disease and the positioning of dental implants

日本歯科先端技術研究所学会誌Vol.9 No.3

臨床研究

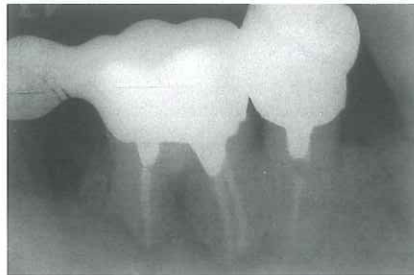
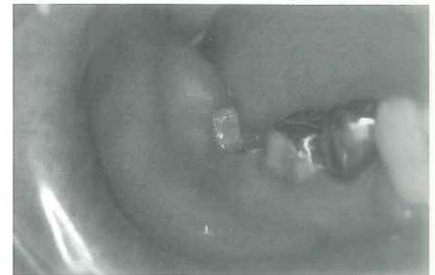
Fig.2-a

Fig.2-a,b: Case No.8 male, 67 years old. It showed an oral finding after removing the crown on the infected implant at the site of the second right lower molar. Swelling was observed at the right side of the alveolar ridge.

症例8 (Fig.2-a~2-d) : 67歳、男性

47欠損、バイオセラムインプラント植立、46と連結鑄造冠が装着されたもので、46に根尖透過像がみられ、それとの距離は0.5mmであった。経過は46の病巣が拡大し、インプラント周囲の歯肉が腫脹、疼痛発現したため、47のインプラントを除去し、症状は軽快した。

In the first case (patient No.8, age 67, male), a alminous implant was placed (Fig.2-a,b). There was one neighboring, non-vital tooth, at the first lower molar position. Apical disease was present in this tooth. The distance between the implant and the site of apical disease was 0.5mm or less on the dental x-ray photo (Fig.2-c). After the implant was placed, the patient complained of pain and swelling around the implant area. An examination of the x-ray showed a translucent area, indicating apical disease. A course of antibiotics and sedatives was prescribed, and the symptoms disappeared. The implant was extracted leading to a discharge of pus (Fig.2-d). After removal, apical disease disappeared and the swelling subsided. In this case, removal of the implant was necessary because of acute inflammation.

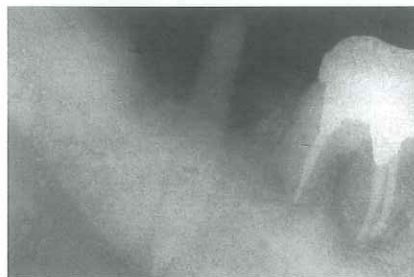
Fig.2-c

Fig.2-c: Case No.8. A dental x-ray photograph showed an apical disease at the site of the second right lower molar.

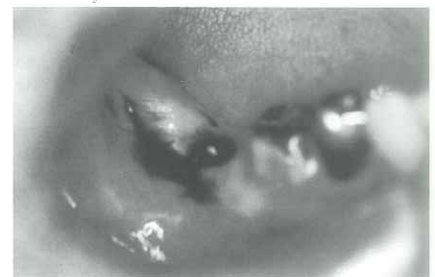
Fig.2-d

Fig.2-d: Case No.8. Pus was discharged from the implant socket after removing the implant.

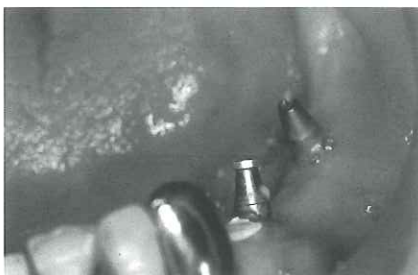
Fig.3-a

Fig.3-a: Case No.79, female, 66 years old. An abscess was observed at the left side of the alveolar ridge.

34失活歯、35にITIインプラントを植立したもので、植立後、34の病変が拡大し、疼痛、腫脹があったため34を抜歯し、その結果、症状は消退した。

The second case (patient No.79, age 66, female) had one non-vital second lower premolar neighboring the implant at a distance of 0.5mm or less. After the placement of two ITI implants, infection occurred around the second lower premolar. The patient complained of discomfort, swelling and pain (Fig.3-a). An abscess appeared, and the x-ray film showed disease in the apical area of the tooth (Fig.3-b). The previous root canal treatment had left some debris, which led to apical disease. The tooth was removed completely after which the infection disappeared completely (Fig.3-c and 3-d).

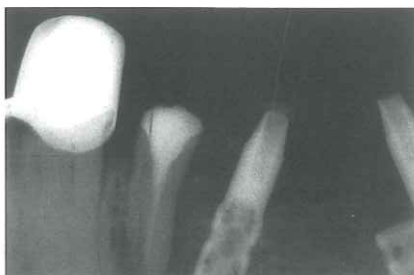
Fig.3-b

Fig.3-b: Case No.79. An apical disease at the site of the second left lower premolar connects to the neighboring implant (ITI implant).
